ACCIDENT INVESTIGATION COORDINATING COMMITTEE
CIVIL AVIATION DEPARTMENT
MINISTRY OF TRANSPORT AND CIVIL AVIATION

**ACCIDENT REPORT ON
8Q-TMC (TWIN OTTER) COLLISION WITH SEAWALL
At Male' International Airport
On 17th of May 2004**

**Operator: Trans Maldivian Airways Pvt. Ltd.
Manufacturer: De Havilland
Model: DHC-6-300 (Floatplane)**

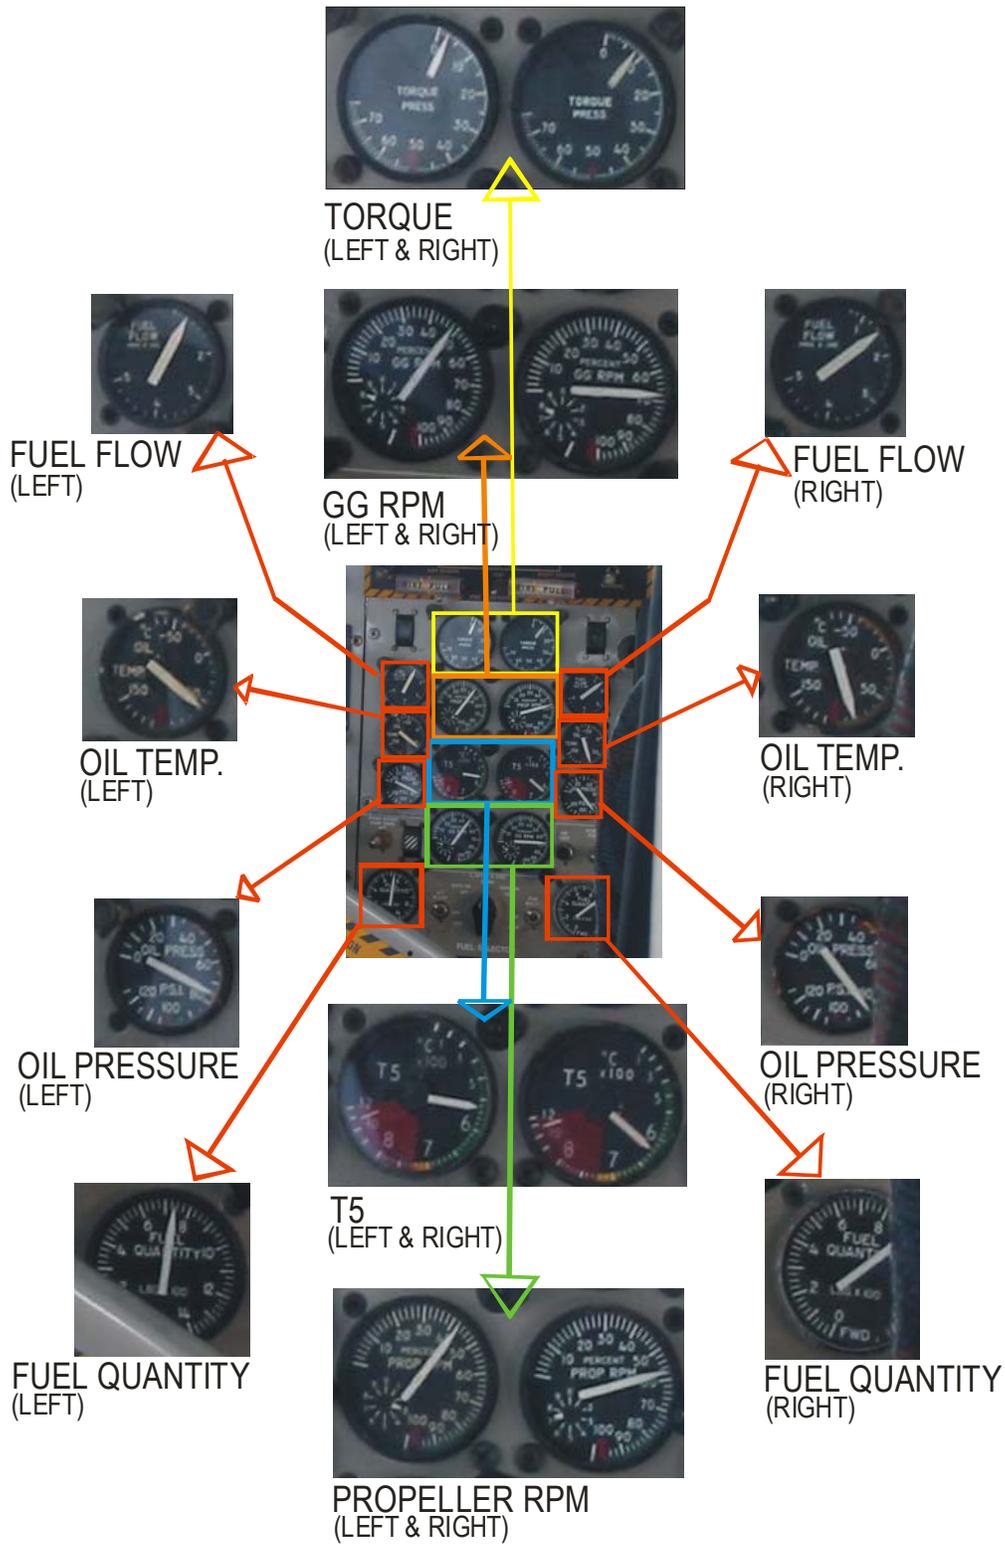
Appendix - A

Appendix A – Engine Instrument Panel (After Accident)

Both engines were removed from aircraft and subjected to a visual and borescope inspection. The visual inspection revealed that the both engine had similar kinds of damage. The exhaust casing cover showed signs of heavy torsion, indication the props were running at the time of impact. The PT blades were in good condition but they were stuck to rotate due to impact. Compressor blades on both the engines were running freely and were in good condition. P3 and Py line showed no indication of leakage. Borescope inspection revealed all the CT blades were in good condition. From the subjected inspections there was no indication of engine malfunctioning.

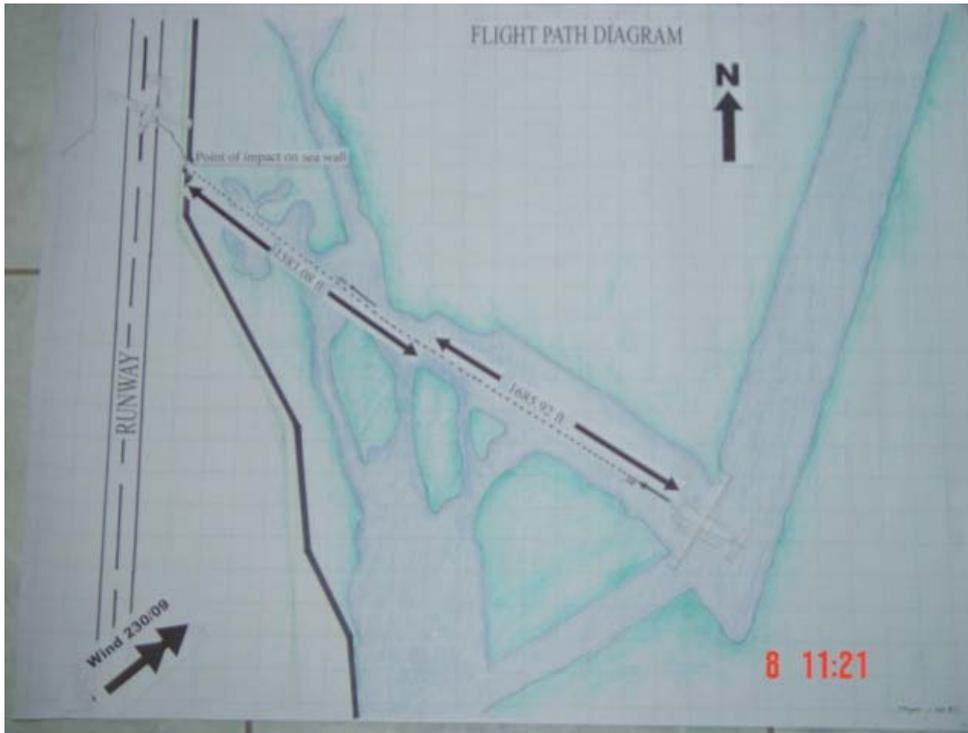
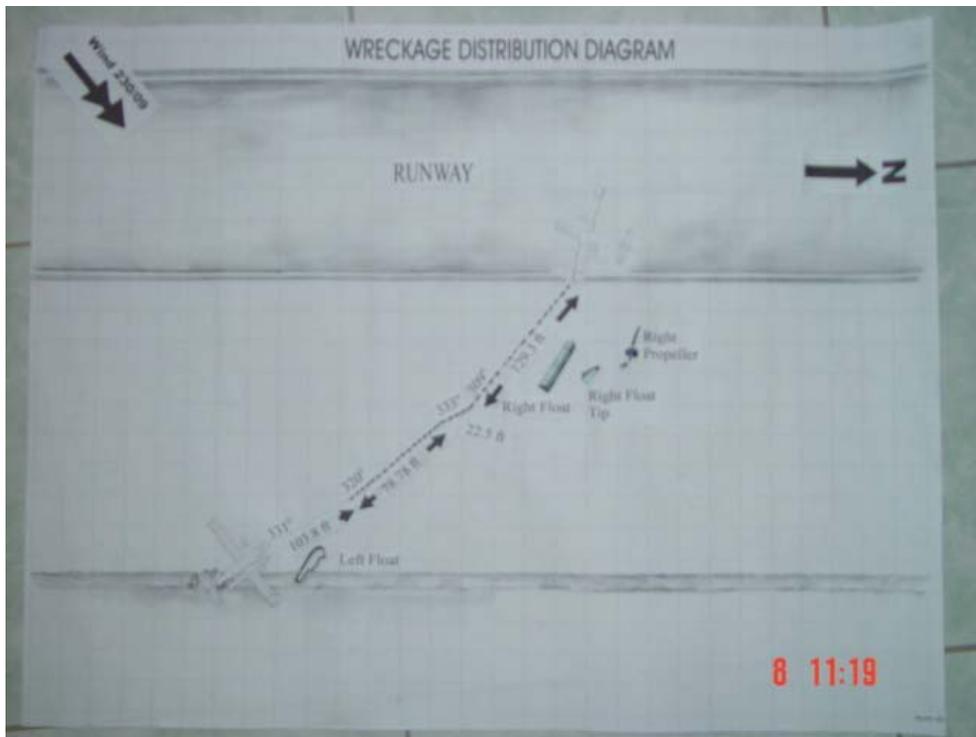
Appendix - B

Appendix B – Flight Path and Wreckage Distribution Diagrams

The first point of contact was with the sea wall in a north westerly direction (309 degrees heading). The impact damage to the seawall was 11ft wide. There was, also, scrape marks on the sea wall 15 ft north of first impact point.

The second impact mark was on the ground 104 ft west of the seawall. Two parallel marks on the ground running north westerly direction (320 degrees) was observed The first mark was up to main asphalt runway, while the second parallel mark was up to the location where the right hand float was lying.
