ACCIDENT INVESTIGATION AND COORDINATING COMMITTEE
CIVIL AVIATION DEPARTMENT
MINISTRY OF TOURISM AND CIVIL AVIATION

**ACCIDENT REPORT ON
8Q-MAS (TWIN OTTER) COLLISION WITH A SPEED BOAT
Near the Floating Platform at Adaaran Club Bathala, Maldives
On 14th of July 2008**

Operator: Maldivian Air Taxi
Manufacturer: De Havilland (Canadian)
Model: DHC-6-300 (Floatplane)

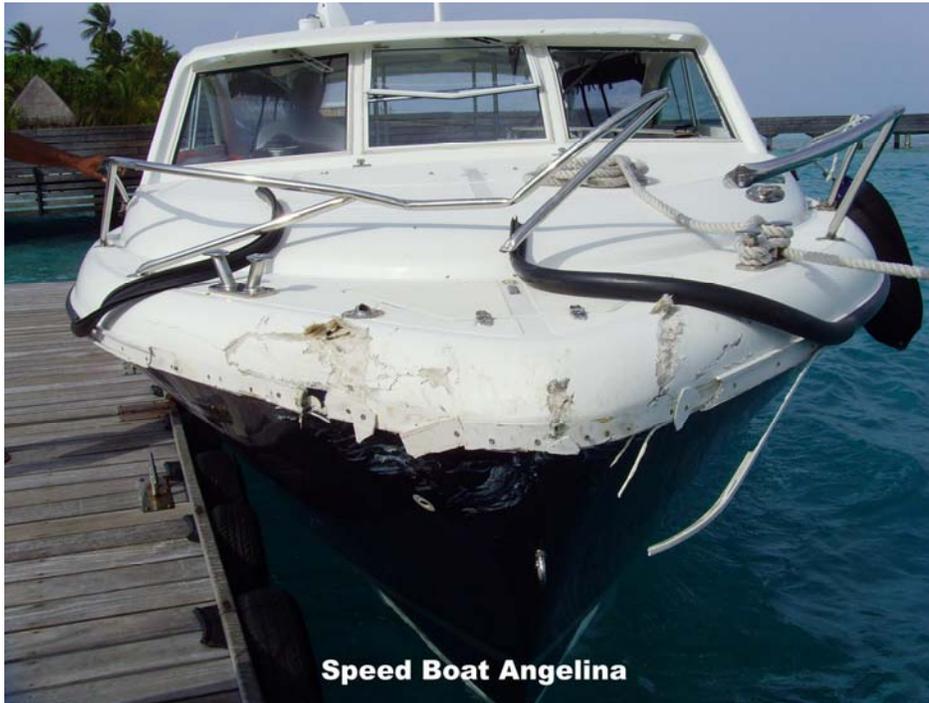
Speed Boat Angelina

The W Retreat and Spa Maldives Resort's Speed Boat (Angelina) (a 34 ft Triana Express) was moored at a buoy (located at 04 04' 43.6" N, 072 56' 37.1" E) used by MAT to moor the aircrafts for night stops. The floating platform was located (04 04' 43.5"N, 072 56' 38.8"E) east of the buoy. The distance between the floating platform and buoy is around 165 feet.

Floating platform was located at 04 04' 43.5"N, 072 56' 38.8"E and the mooring buoy was located at 04 04' 43.6"N, 072 56' 37.1"E. The speed boat was moored to her stern by a 23 feet mooring line from the buoy and the engines were off. The speed boat was heading Easterly with the currents.

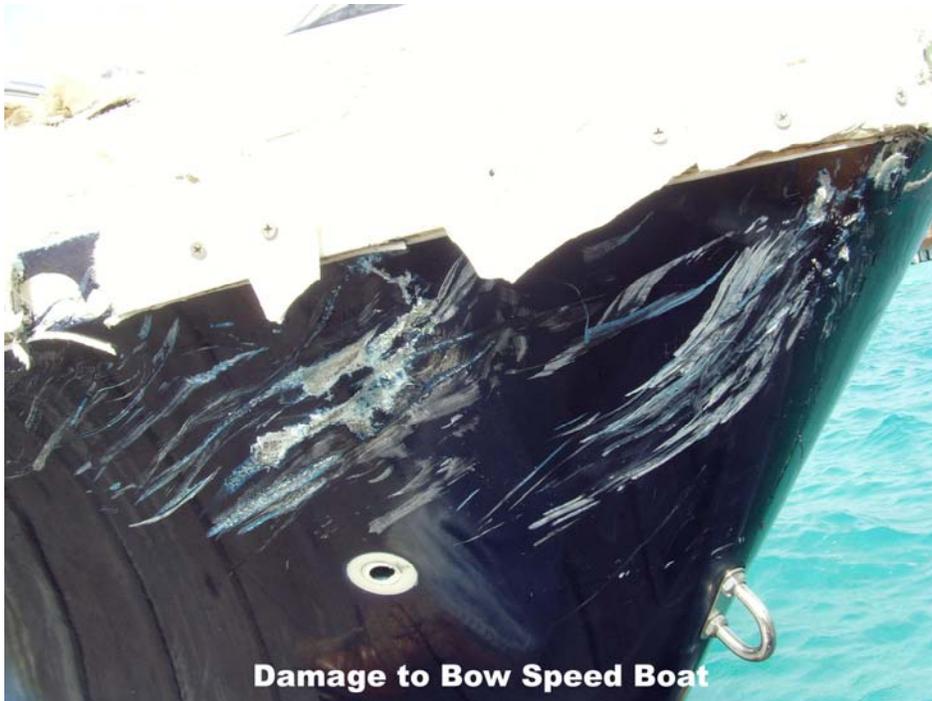
The front railing of the speed boat was crushed; the LH windshield shattered, the bow was scratched.

- The crew of the aircraft acted swiftly to save lives, after the aircraft came to a halt.
- Investigation revealed that some metal parts of float were embedded in the bow of speed boat, indicating the aircraft float had impacted with the speed boat.

Damage to Bow Speed Boat
