ACCIDENT INVESTIGATION COORDINATING COMMITTEE

ACCIDENT REPORT ON 8Q-TMD
(Twin Otter crash at Maadhiggaru Falhu, South Male'
Atoll, Maldives on 11th July 2011)

Operator: Trans Maldivian Airways
Manufacturer: De Havilland (Canadian)
Model: DHC-6-300 (Floatplane – Wipaire 13000)

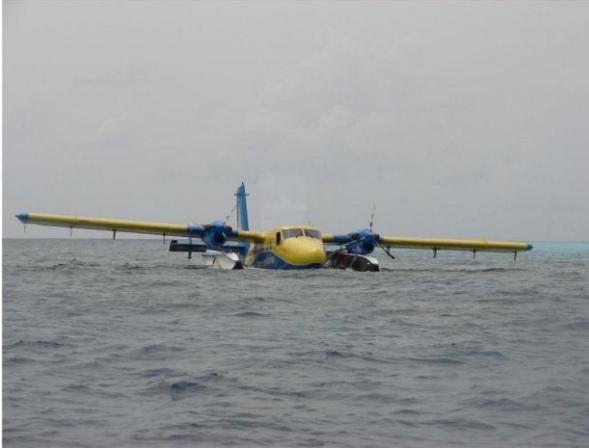
Appendix 1

Both LH and RH Float was almost detached from the aircraft and twisted with a cut out formed on the forward of the floats by propellers (appendix 1). Both LH and RH wing struts were bent (appendix 2). Blade tips on both propellers were bent and some part torn off (appendix 3). RH forward step and RH rear stem were detached from aircraft and found near the aircraft wreckage.

Both floats almost detached from aircraft and twisted

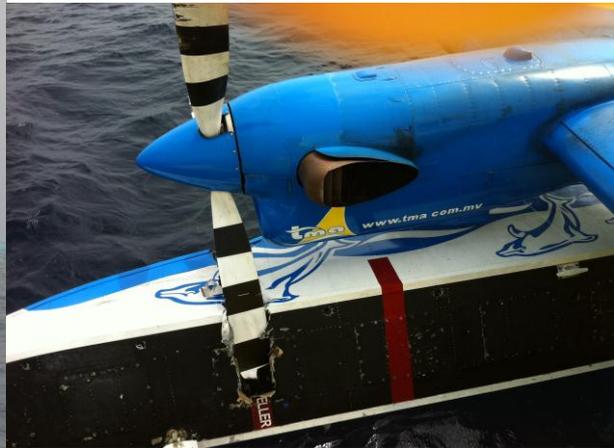
As per the crew, the aircraft initial touch down was smooth. However, they stroke a wave which made the aircraft bounce up for about 20 feet. With the low power the aircraft hit the water again, resulting in multiple float attachments to break. Both front and main spreader bars broke and floats rose up twisted, hitting the engine bottom cowlings. Propeller cut was found on top front of both floats.

Propeller cut on right float

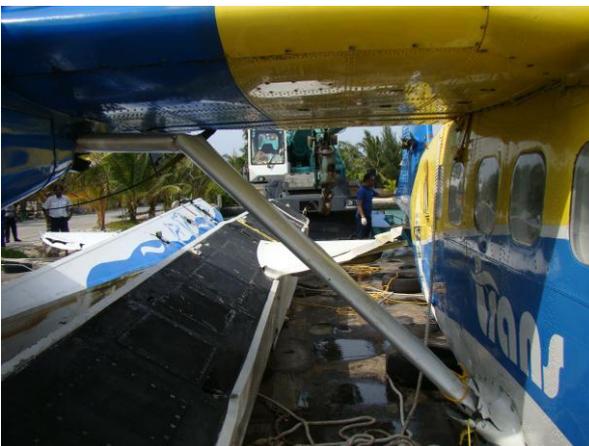
Appendix 2

RH wing strut damaged

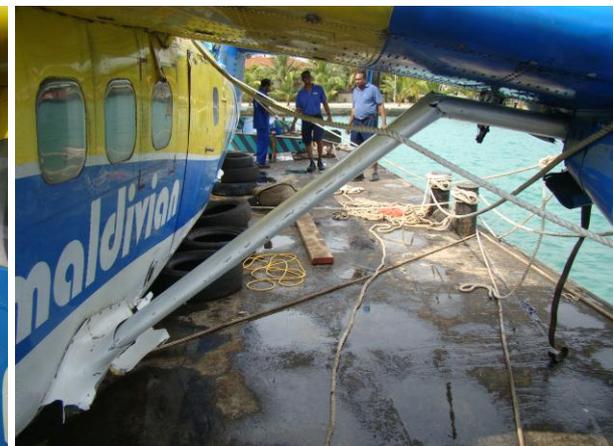
LH wing strut damaged

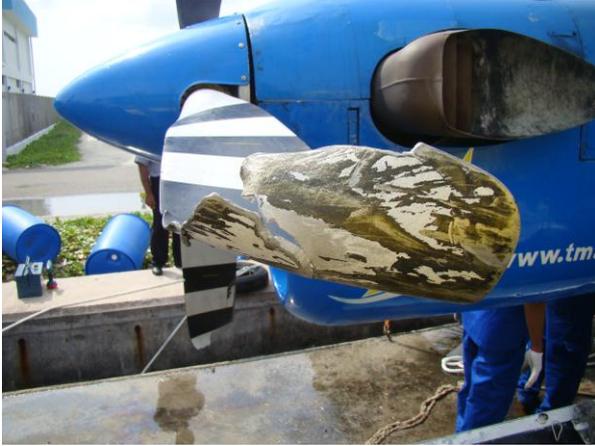
Appendix 3

RH Propeller blades bent and some parts worn off

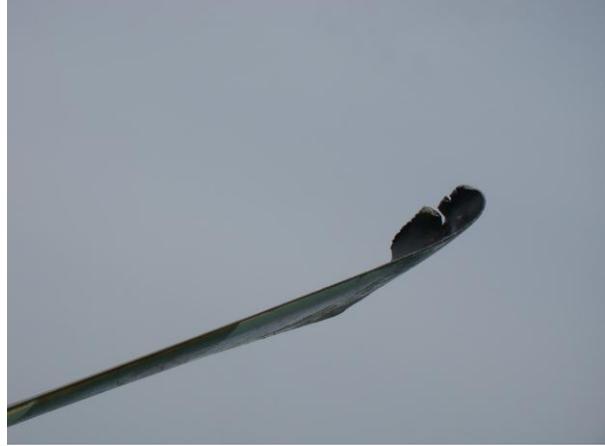
LH propeller blade damage

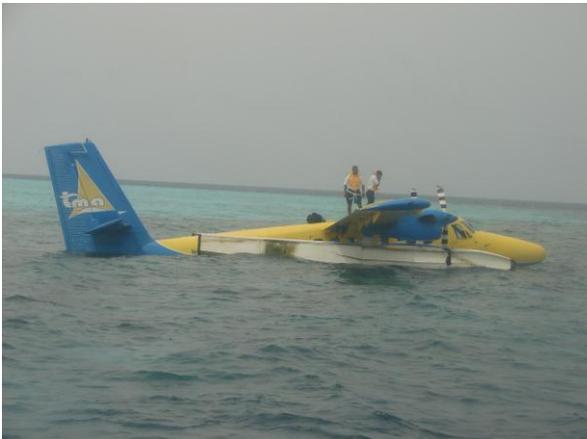
Appendix 4

Substantial damaged was done to the aircraft due the fact that it was on the reef half submerged for almost three days (appendix 4). Further damage was caused during the salvage operation (appendix 5)

Aircraft half submerged (on the day of accident)

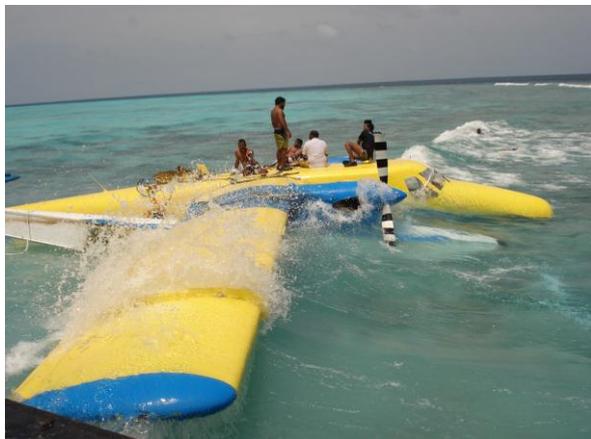
Aircraft half submerged (after 2 days of accident)

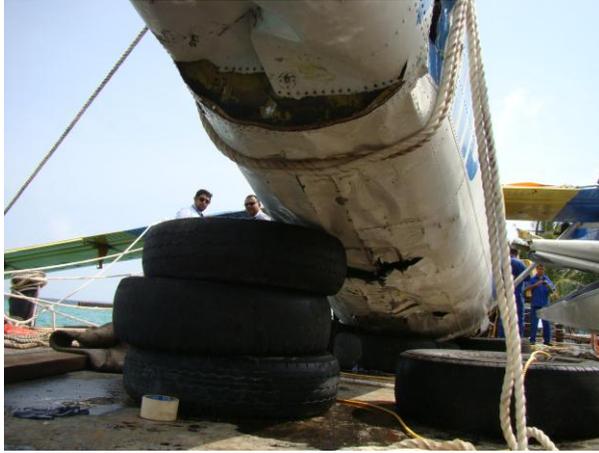
Appendix 5

Interviews with the crewmembers were carried out and these were compared with the actual damage to the aircraft. Engineers damage analysis reports and photographs were analysed to identify the actual damage as there were secondary damage on aircraft due to current, waves and the reef (appendix 5). Also more damage occurred during the salvage operation.

Secondary damage by current, reef and waves

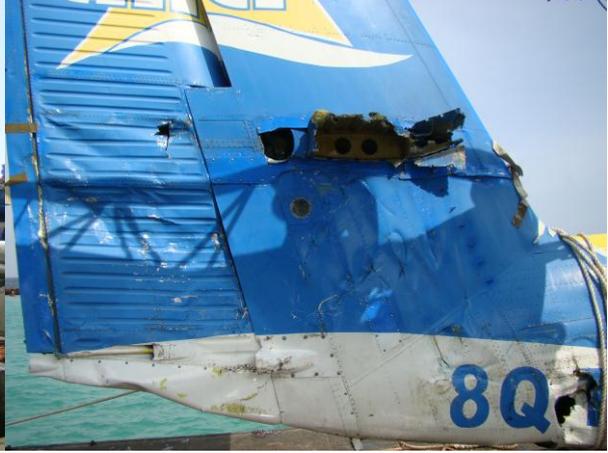
Damage during salvage operation

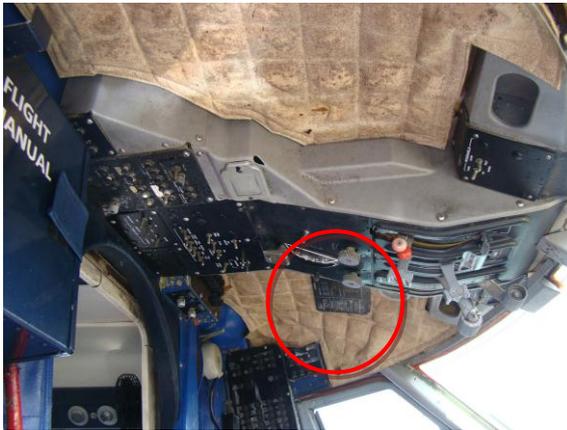
Appendix 6

- As per the wreckage pictures, the flap selector was set to zero flaps and the flap angle indicator showed zero flaps (appendix 6). Some of the external photos taken by crewmembers while the aircraft was drifting also shows the flap was at zero position.
- As per the metallurgy report, no obvious indications of fatigue or other pre-existing crack were visible. These factors are suggestive of an overload failure indicating that the load experienced during the incident exceeded the strength of the materials. (Appendix 8)

Flap selector shows zero flaps

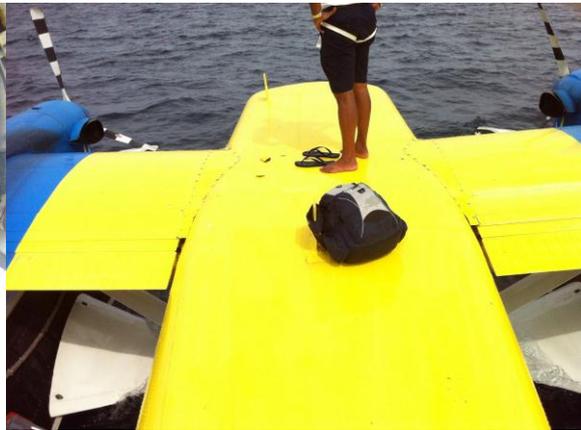
Aircraft Flap position at zero
(before the rescue team arrived)
