ACCIDENT INVESTIGATION COORDINATING COMMITTEE

**ACCIDENT REPORT ON
Cessna 150, 8Q-GAB at
Gan International Airport, Maldives
on 1st February 2012**

Operator: Asian Academy of Aeronautics
Manufacturer: Cessna Aircraft Company
Model: Cessna 150L

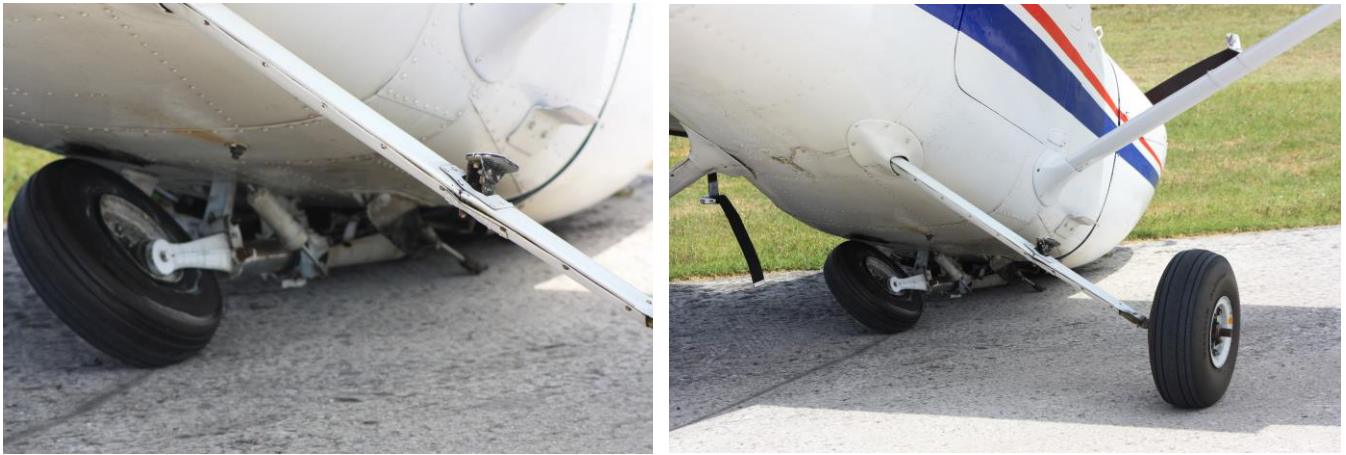
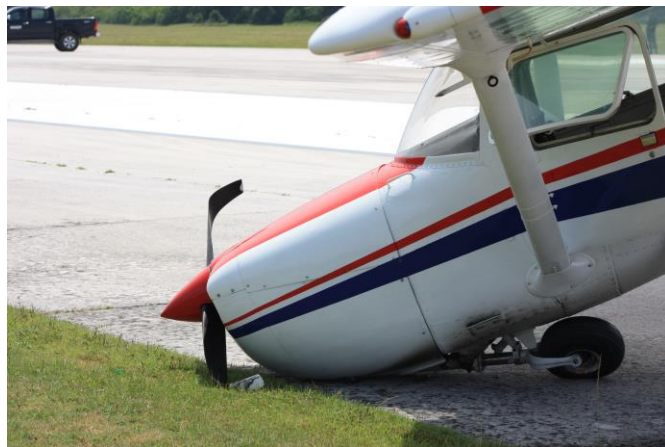
Appendix 1

The aircraft sustained significant damaged. Nose landing gear collapsed (appendix 1) and detached from the engine mount on landing (appendix 2). Engine mount frame was significantly damaged and distorted (appendix 6). The propeller stuck the runway when the nose wheel collapsed causing both blades to be bent (appendix 4 and 5) and the engine to cease. Significant skin damage to the underside of the nose, aft of the landing gear, (appendix 3) on contact with the tire.

The nose landing gear collapsed on landing

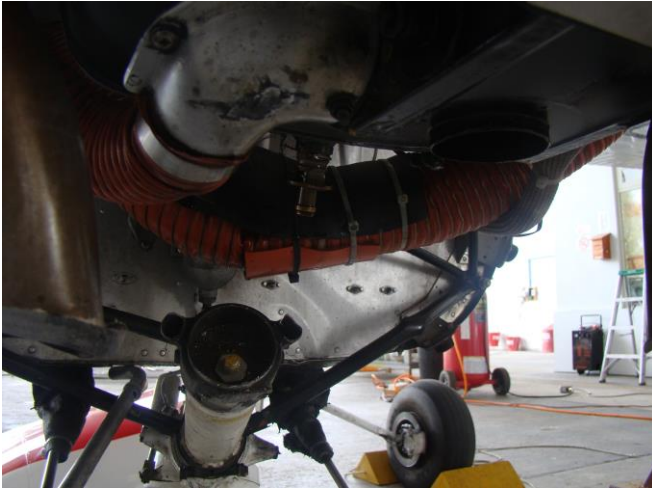
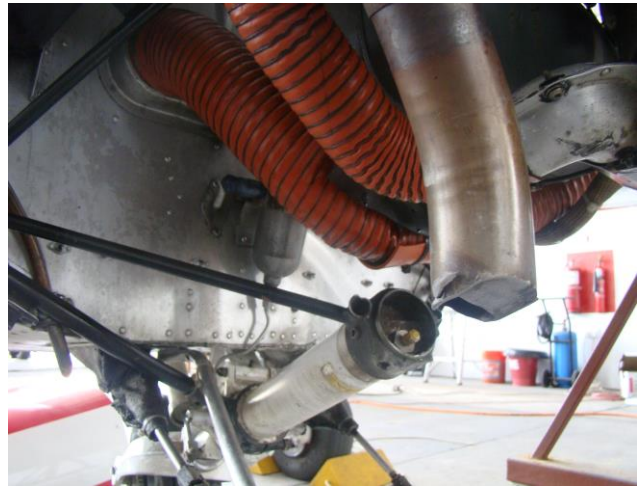
Appendix 2

The landing gear was detached from the engine mount

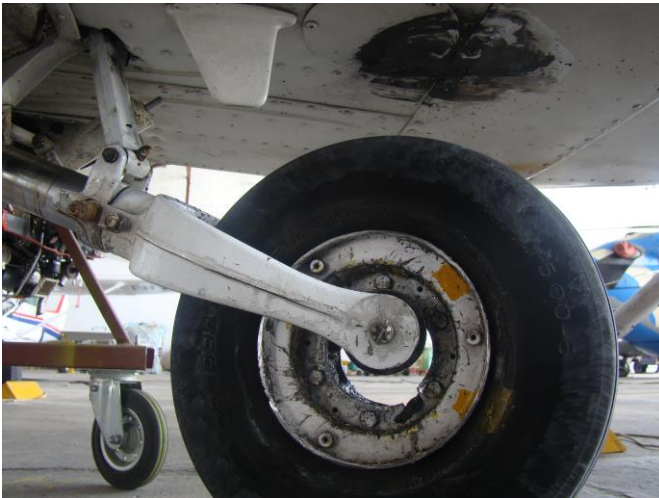
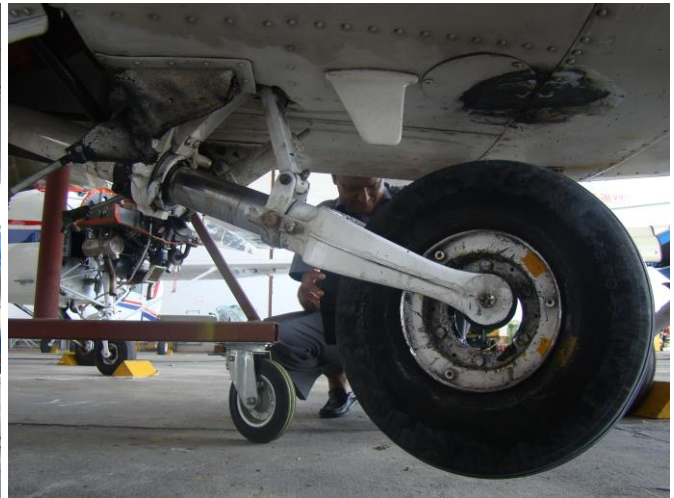
Appendix 3

The tire rubbed against the belly by the landing gear causing skin damage

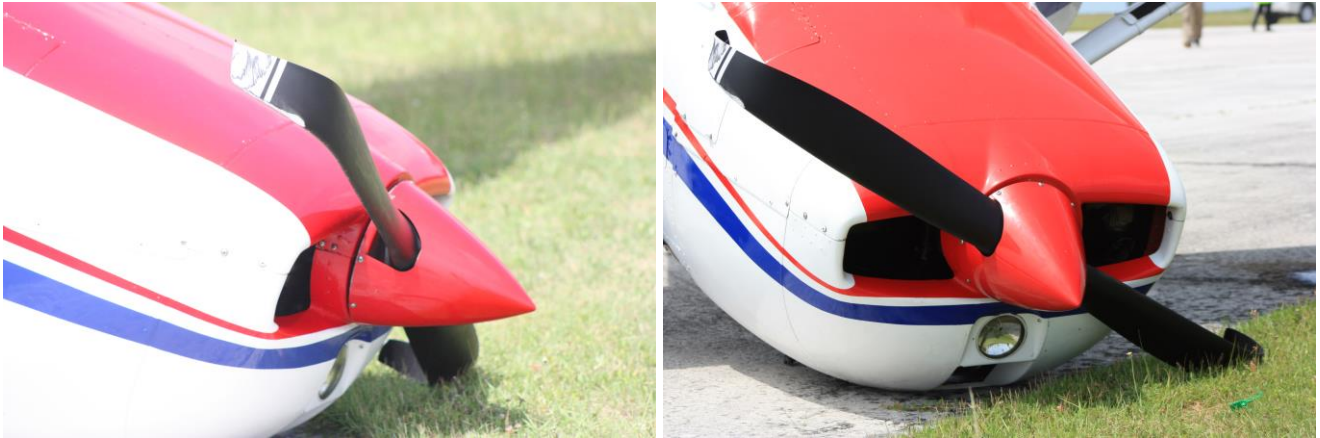
Appendix 4

Prop struck the ground when the landing gear collapsed

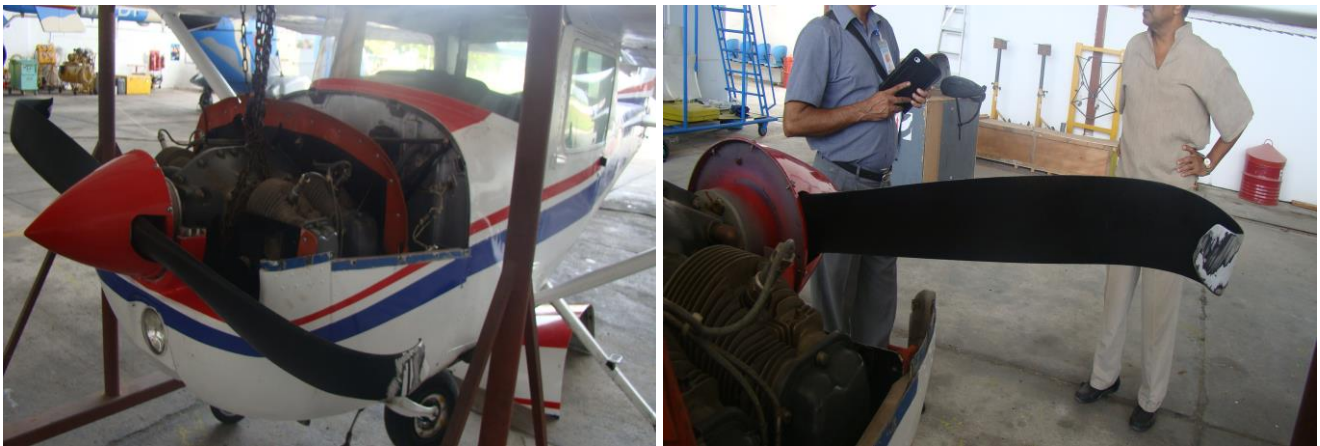
Appendix 5

Tip of both the blades were bent

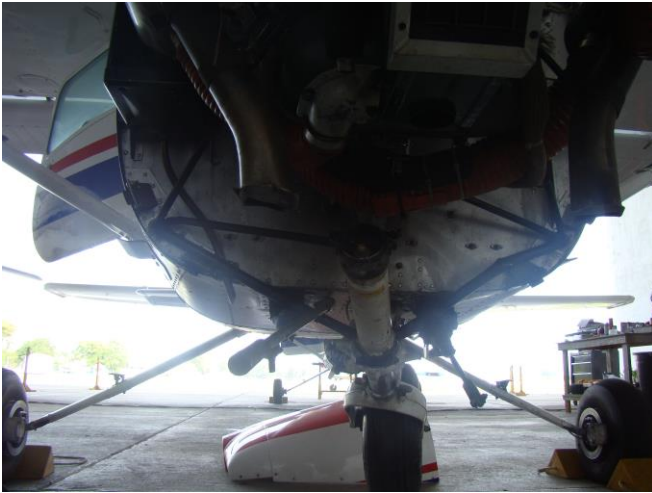
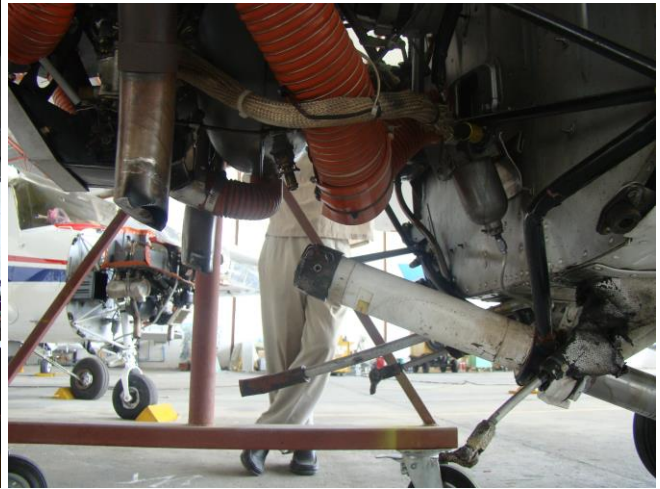
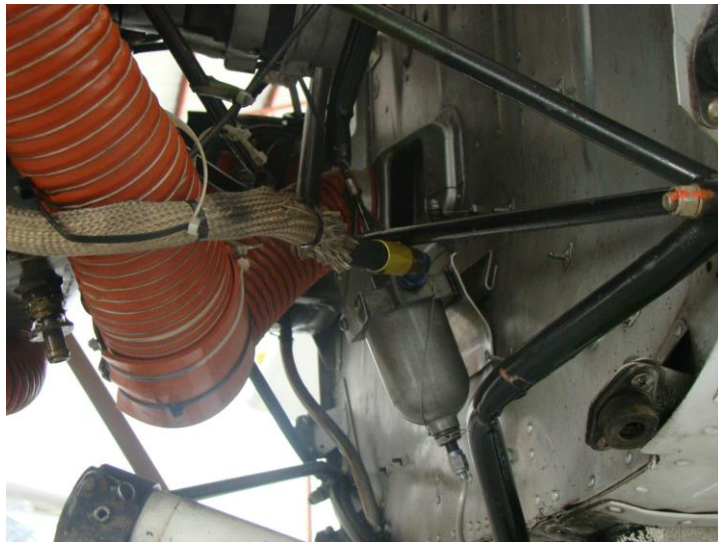
Appendix 6

Engine mount frame damaged and broken
