ACCIDENT INVESTIGATION COORDINATING COMMITTEE

**ACCIDENT REPORT ON
8Q-MAT (TWIN OTTER)
At the Ibrahim Nasir International Airport, Water Runway,
Maldives
On 09th February 2012**

Operator: Maldivian Air Taxi
Manufacturer: De Havilland (Canadian)
Model: DHC-6-300 (Floatplane)

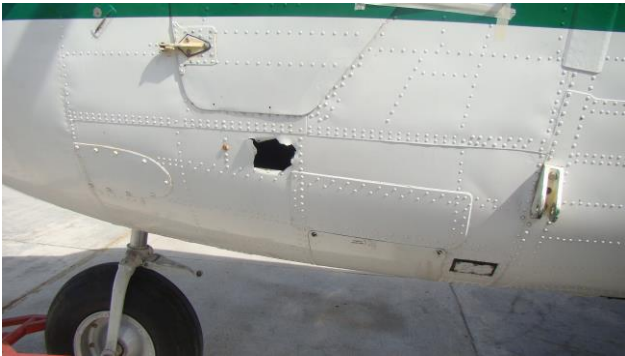
Appendix 1

L/H side skin had a gaping hole right below the door of the captain door. Fuselage Station: 83.00 (Appendix 1)

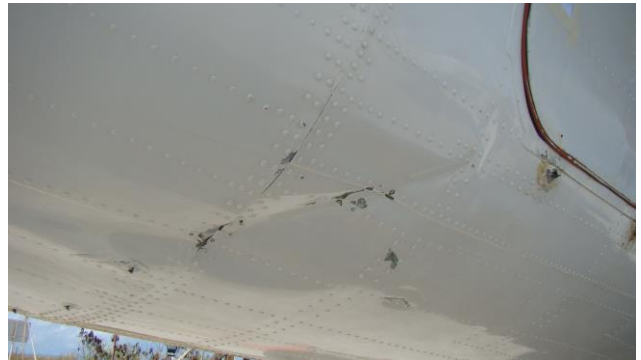
Appendix 2

R/H side skin and structure damage under the belly by the right hand cabin door. Belly skin, stringers and bulkhead was damaged. Between Fuselage Stations: 312.50 & 347.00 (Appendix 2) (Appendix 3)

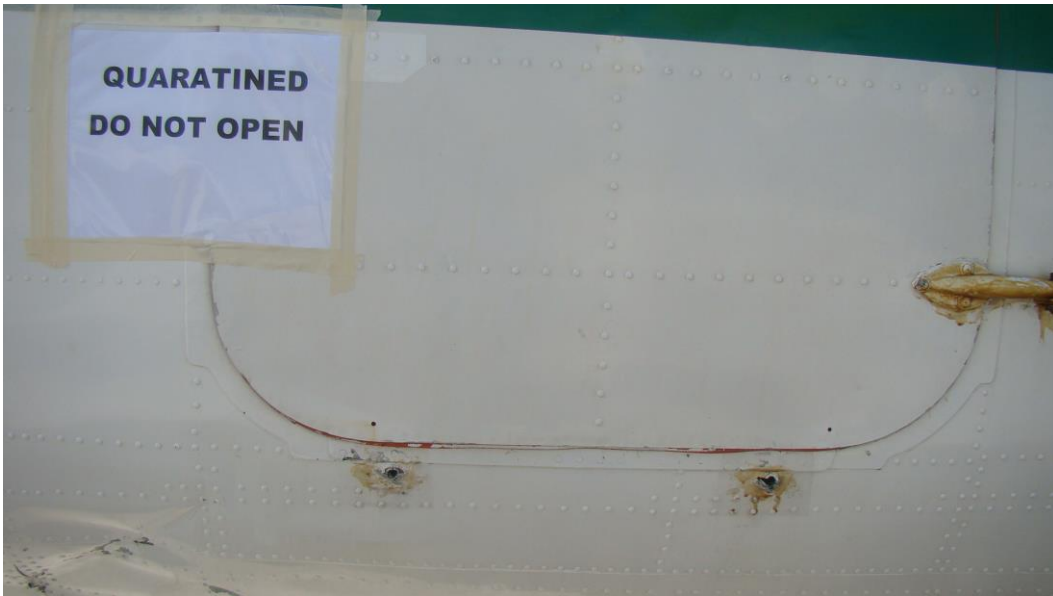
Appendix 4

R/H passenger door step strut attaching nut plates ripped out. Fuselage Station: 300.00 & 312.00 (Appendix 4)

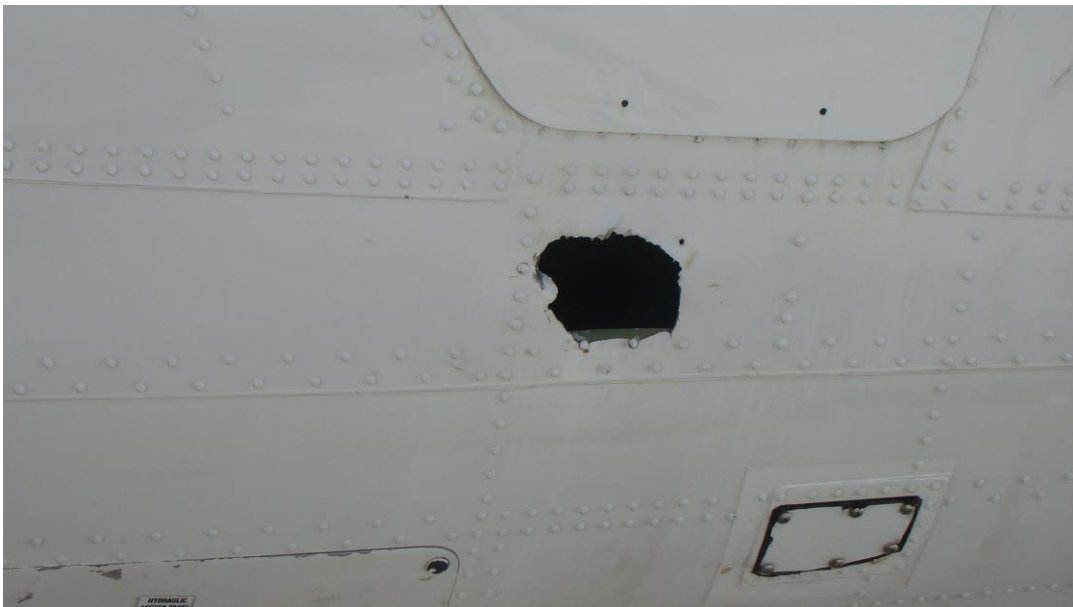
Appendix 5

R/H side skin had a gaping hole right below the door of the co-pilot door. Fuselage Station: 83.00 (Appendix 5)

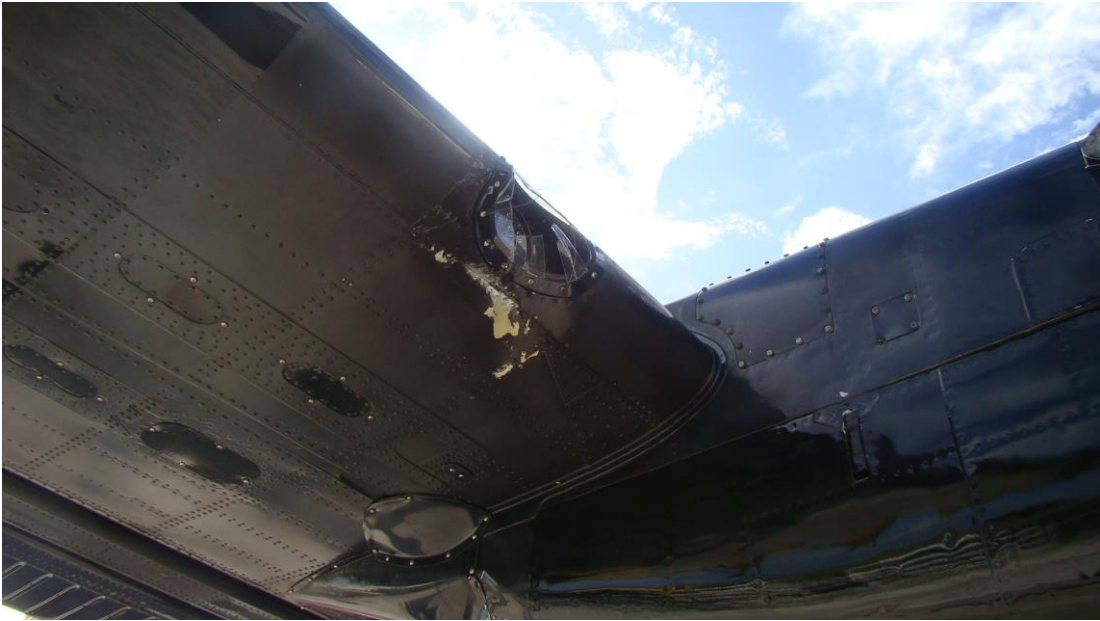
Appendix 6

Leading edge skin, lower forward skin, adjacent stringers & rib bent & buckled, Leading edge skin & forward skin under the wing was damaged. Between Wings station 135.00 & 147.00 (Appendix 6) (Appendix 7)

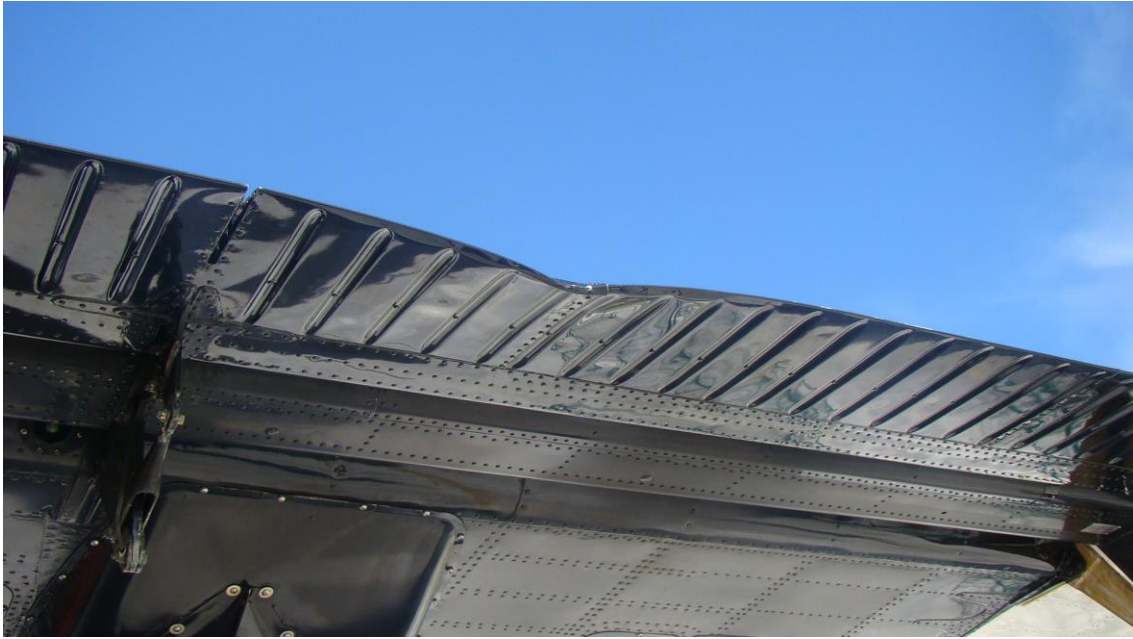
Appendix 8

Inboard trailing edge flap and trailing edge skin was damaged. Between Wings station 97.50 & 122.50 (Appendix 8)

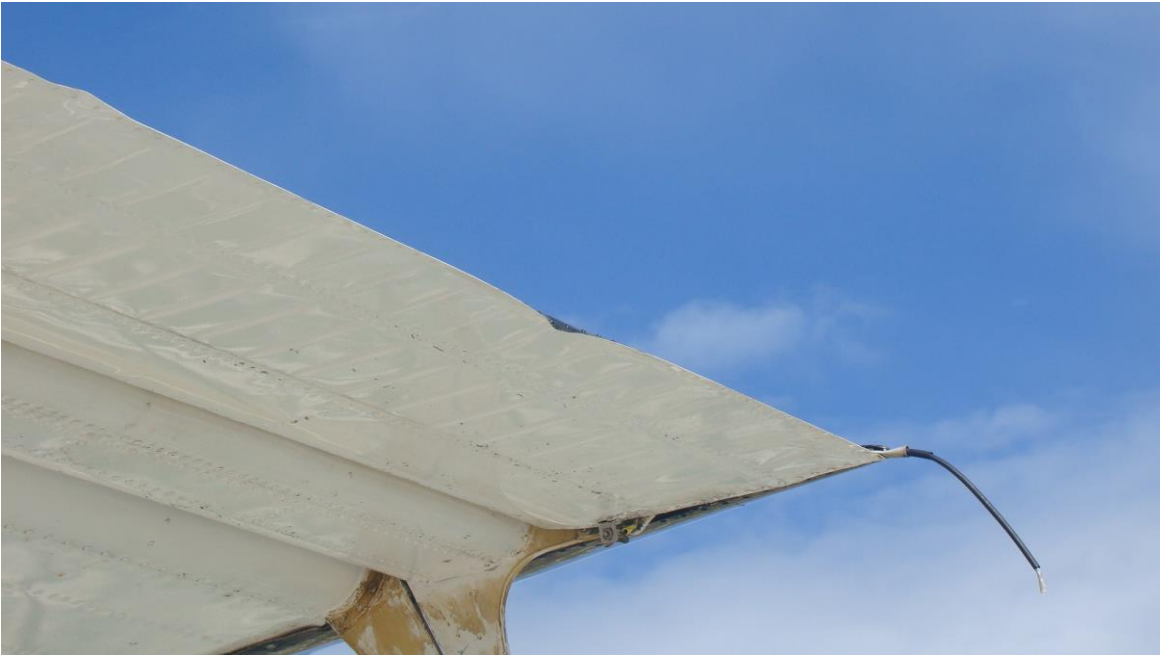
Appendix 9

Several dents were on aileron trailing edge skin. (Appendix 9)

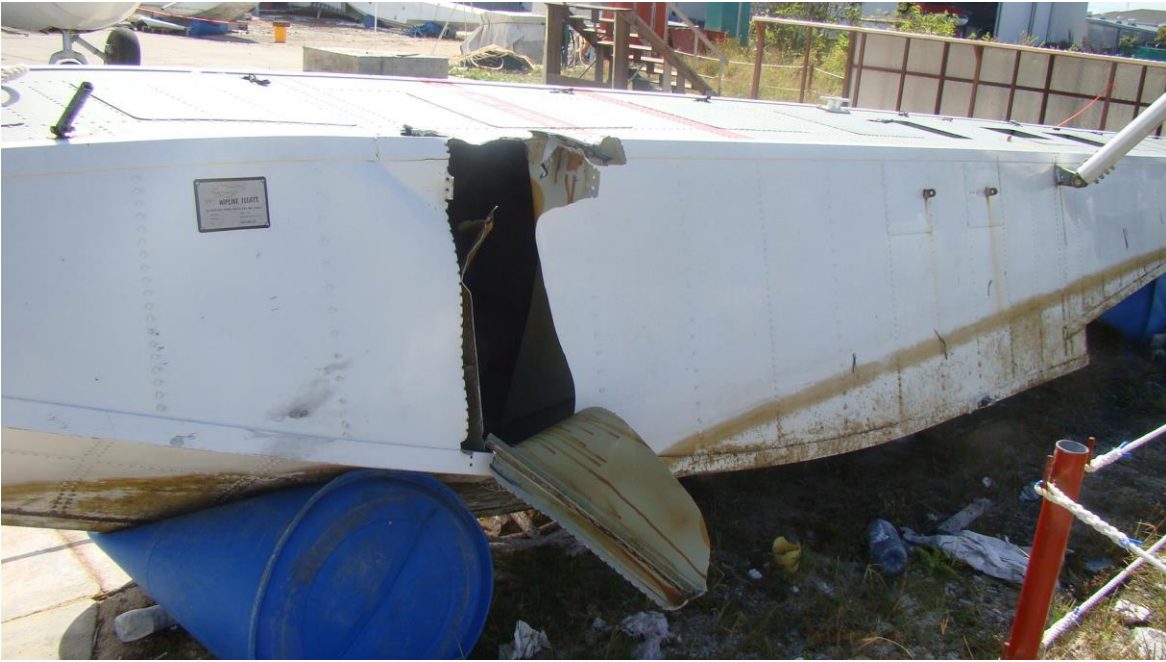
Appendix 10

RH Float was twisted and detached from the aircraft. Forward strut attaching point and adjacent support structure bulkhead was badly damaged, fittings and supporting structure parts needs to be replaced. (Appendix 10)

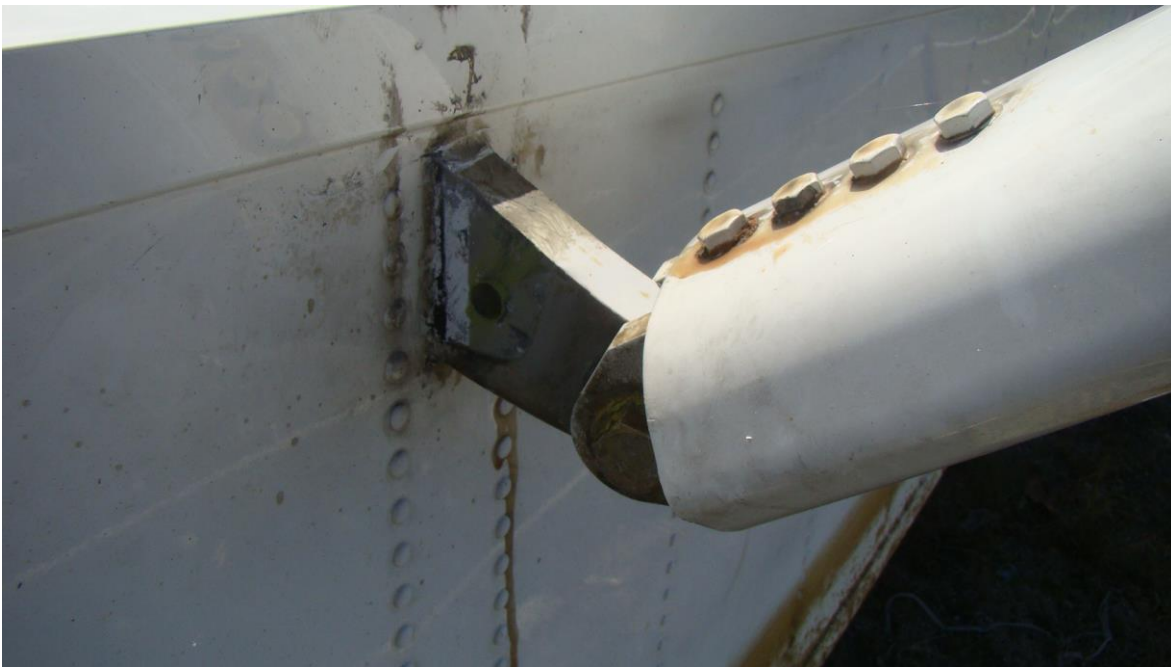
Appendix 11

Main strut and aft spreader bar mounting fitting at bulkhead bent. (Appendix 11) (Appendix 12)

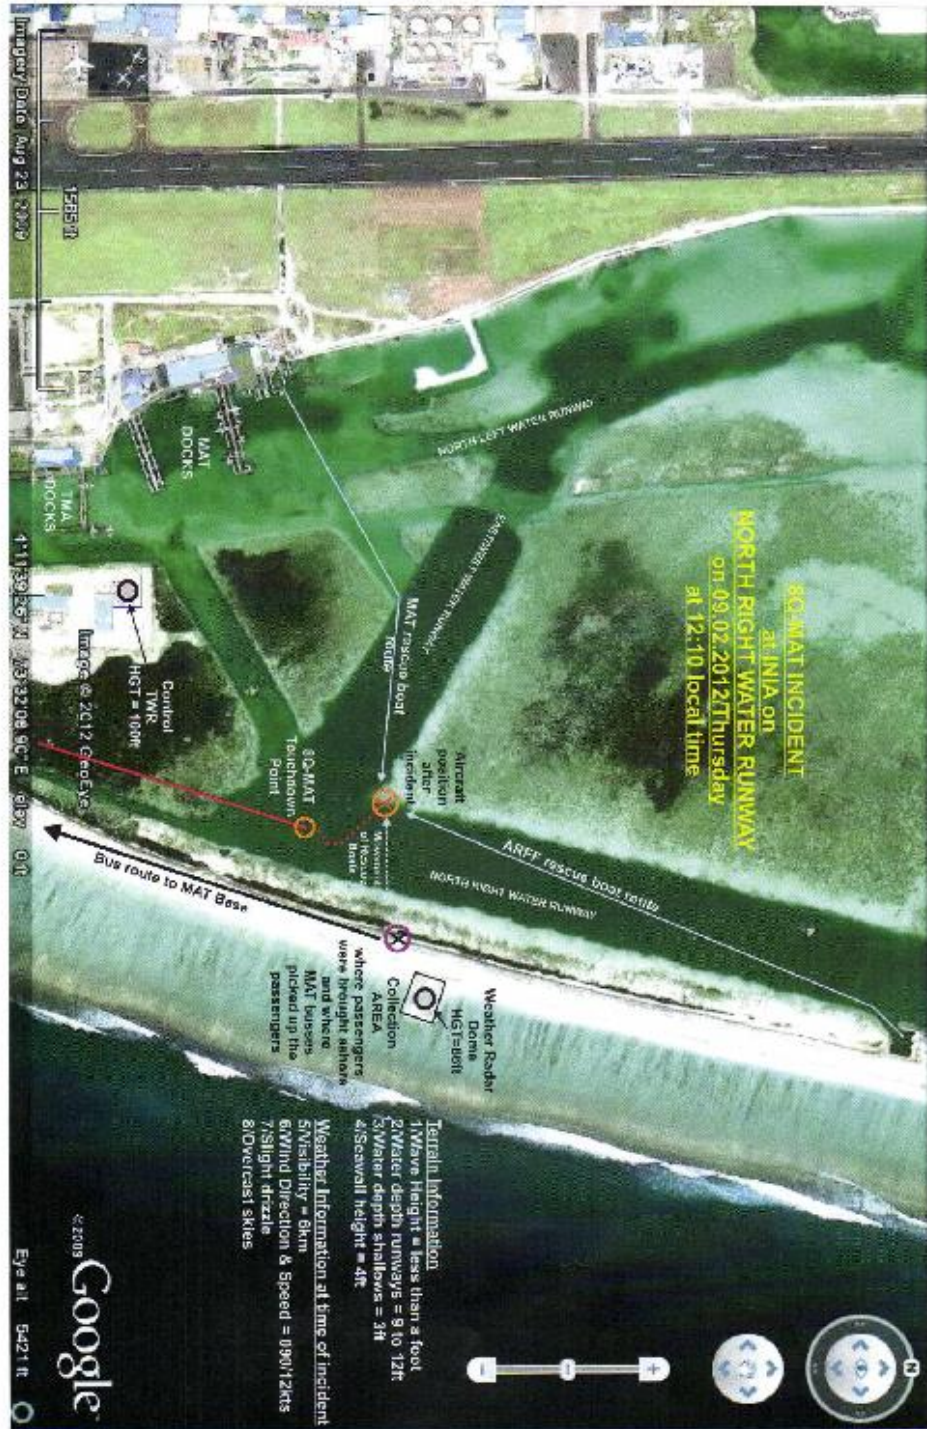
Appendix 15

At the time of the accident the aircraft landed on the north right water runway (Appendix 15).
