ACCIDENT INVESTIGATION COORDINATING COMMITTEE

**INCIDENT REPORT ON
8Q-VAS (ATR 72-212A)
Gan International Airport, Addu City, Maldives
On 21st May 2015**

Operator:	Villa Air Private Limited
Manufacturer:	Avions de transport régional (ATR)
Model:	ATR 72-212A (600)

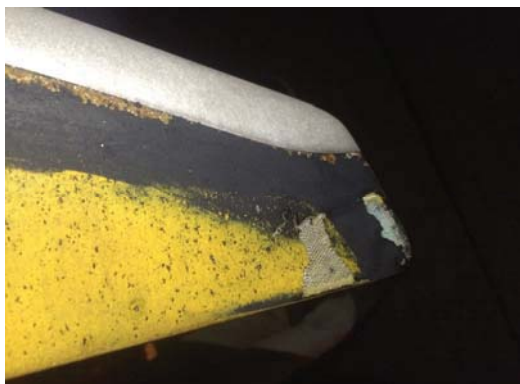
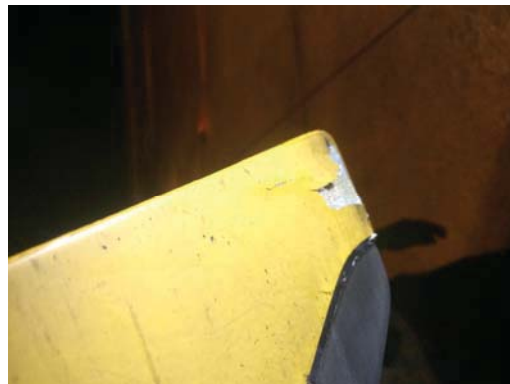
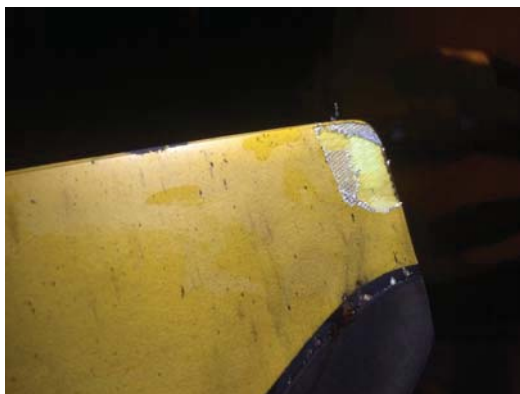
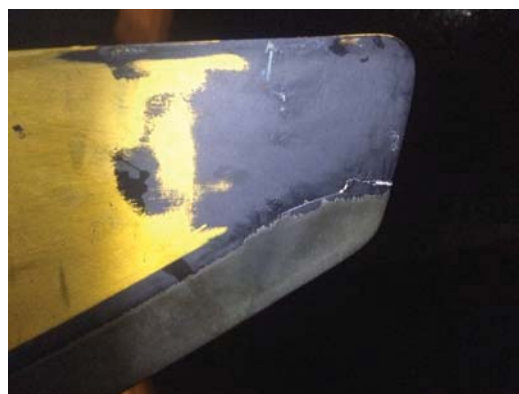
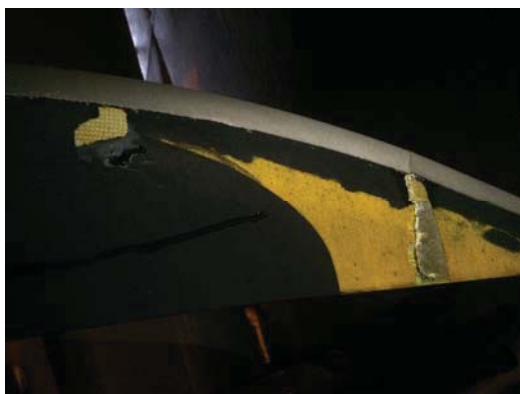
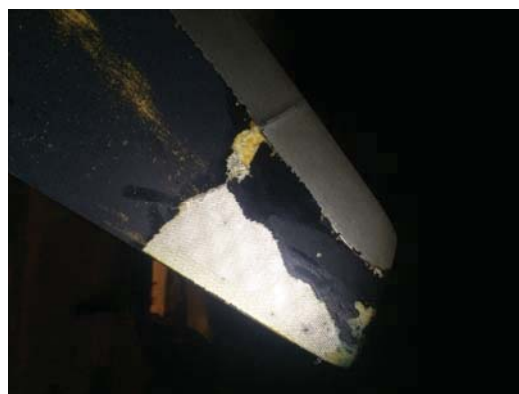
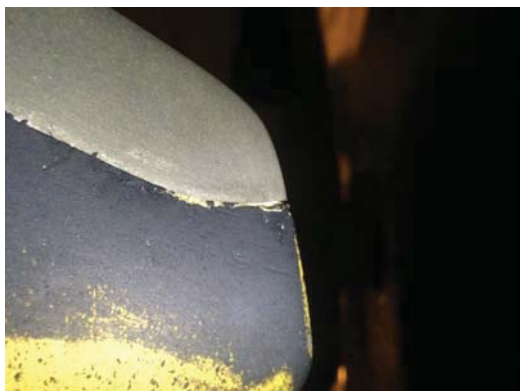
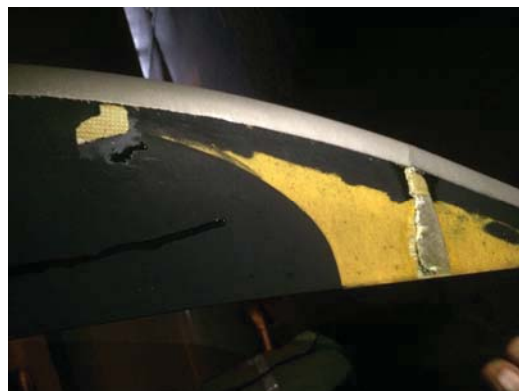
Appendix 1 -Damages to Propeller Blades

1. No. 2 main wheel found with FOD. (Something sharp has pierced into the tire, however no signs of air leakage from the wheel)
2. No.3 main tire found with a small damage on the sidewall. Piece of rubber of approx. 4 inches missing.
3. RH propeller total of 5 propeller blades damaged. (Propeller blades appeared to have hit the runway-Appendix 1)
4. Tail skid has evidence of touching the runway surface.

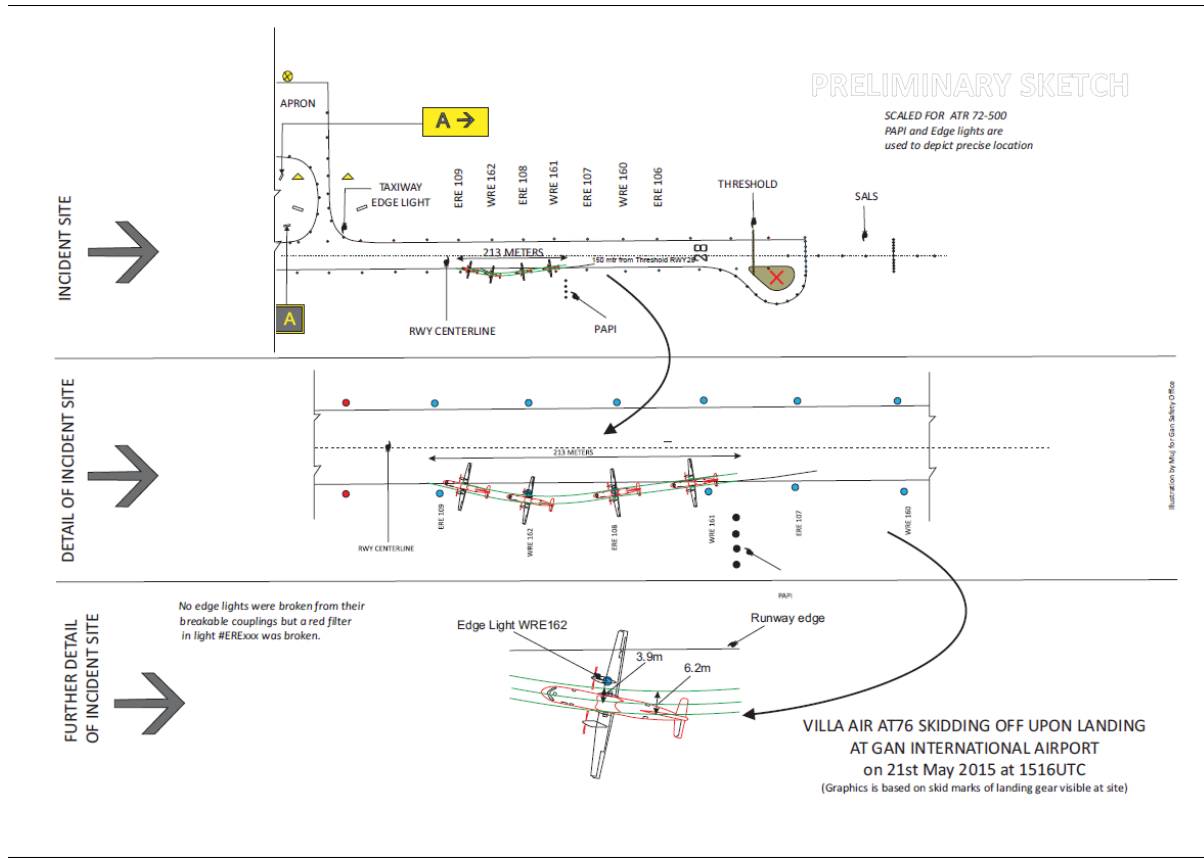
Appendix 2 – Incident Site

The FDM showed that the main landing gear touched down to the left of the centerline before the touchdown zone markings and skidded to the left leaving the runway and moved through grass for about 213 meters (702 feet) before coming back onto the runway.

3. CAA to evaluate the 8Q-VAS SARA FDM reports in conjunction with this incident and advise Villa Air on further corrective actions as required.
4. CAA to evaluate GAN runway surface conditions due to reports of moss and standing water and recommend corrective actions.

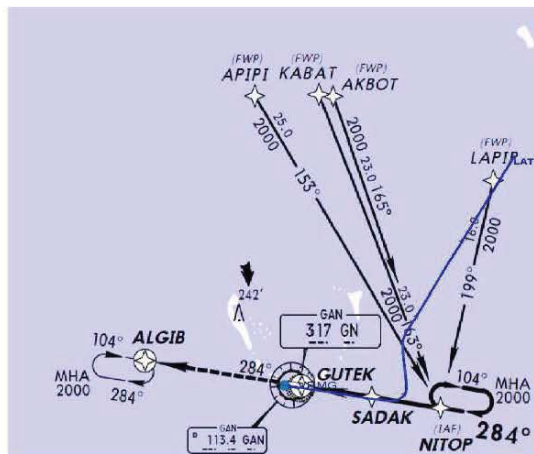
Figure 2 : Trajectory of the airplane over plotted on the GPS Rwy 28 approach chart

According to the trajectory of the airplane, the crew seemed to directly point SADAK, navigation aid published as the Final Approach Fix of GPS Rwy 28 approach chart.

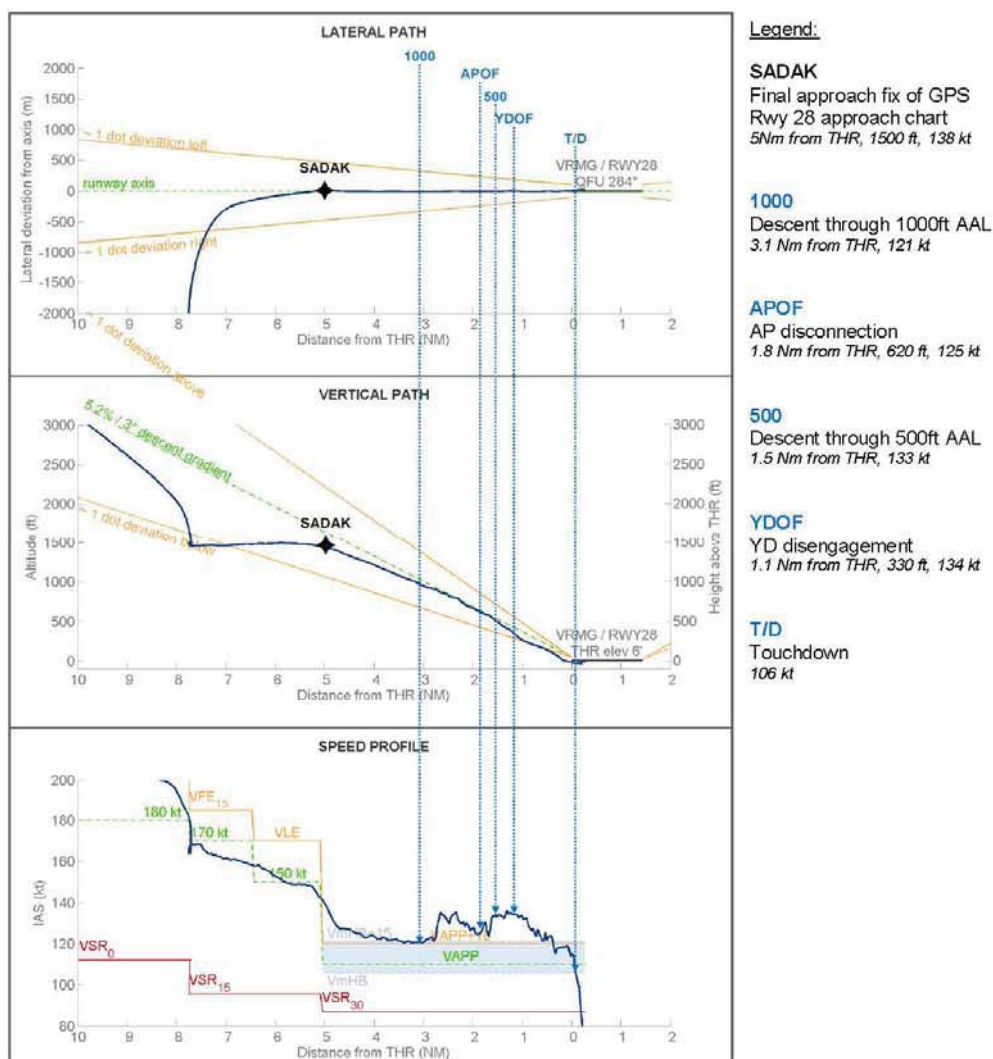
Figure 3 : Reconstructed approach plot based on QAR read out

The airplane flew towards the runway axis with a 90° path from the north with AP engaged in LNAV and ALT modes. It was fully configured for landing just before reaching SADAK (FAF of GPS Rwy 28 approach) at 1500ft and 5 miles away from runway 28 threshold. From there, the airplane remained on lateral path until the touchdown.

The final approach was initiated when ALT mode was replaced by VS mode initially set at -700 ft/min and quickly changed to -600 ft/min. Lateral mode remained LNAV mode (LNAV switched to LNAV LO descending through 930ft).

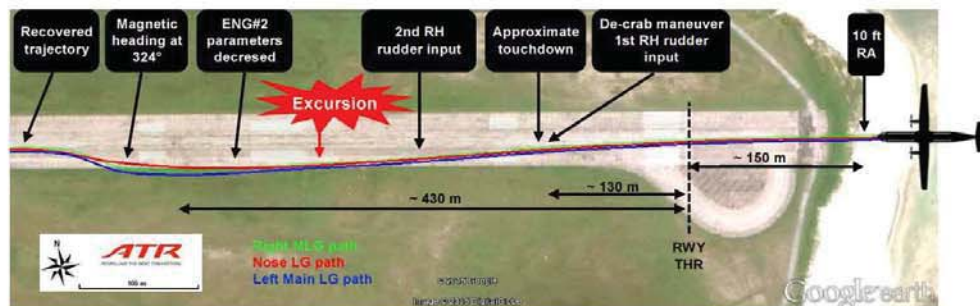
Figure 4 : Reconstructed landing path based on QAR read out

A flare was commanded when the airplane was at around 10 ft RA and at 150 m from the runway threshold. The F/O pitch control input average was around 10 daN. A peak of force at 20 daN allowed the airplane to flare over the beach in front of the runway and the displaced threshold. The airplane flew over the runway threshold at around 4 ft RA. The power levers were retarded to FI position.

The magnetic heading of the airplane was 280° (runway QFU was 284°). A de-crab manoeuvre (1st significant RH rudder pedal effort) was performed just prior or while the MLG touched the ground.

The touchdown could not be evaluated with precision as aircraft accelerations were not available in the QAR. The MLG of the airplane might have touched the ground at around 130 m after the runway threshold, at around 106 kt with a pitch attitude of about 1.4° and a left roll angle (around 3°). The power levers remained in FI position (TQs decreased to 0%) until the nose gear touched the ground. The CAPT reported the "touchdown was smooth".
