ACCIDENT INVESTIGATION COORDINATING COMMITTEE

AIRCRAFT ACCIDENT REPORT 2015/02

**FINAL REPORT ON THE ACCIDENT TO
CESSNA 150, 8Q-GAC AT
GAN INTERNATIONAL AIRPORT, MALDIVES
ON 8th OCTOBER 2015**

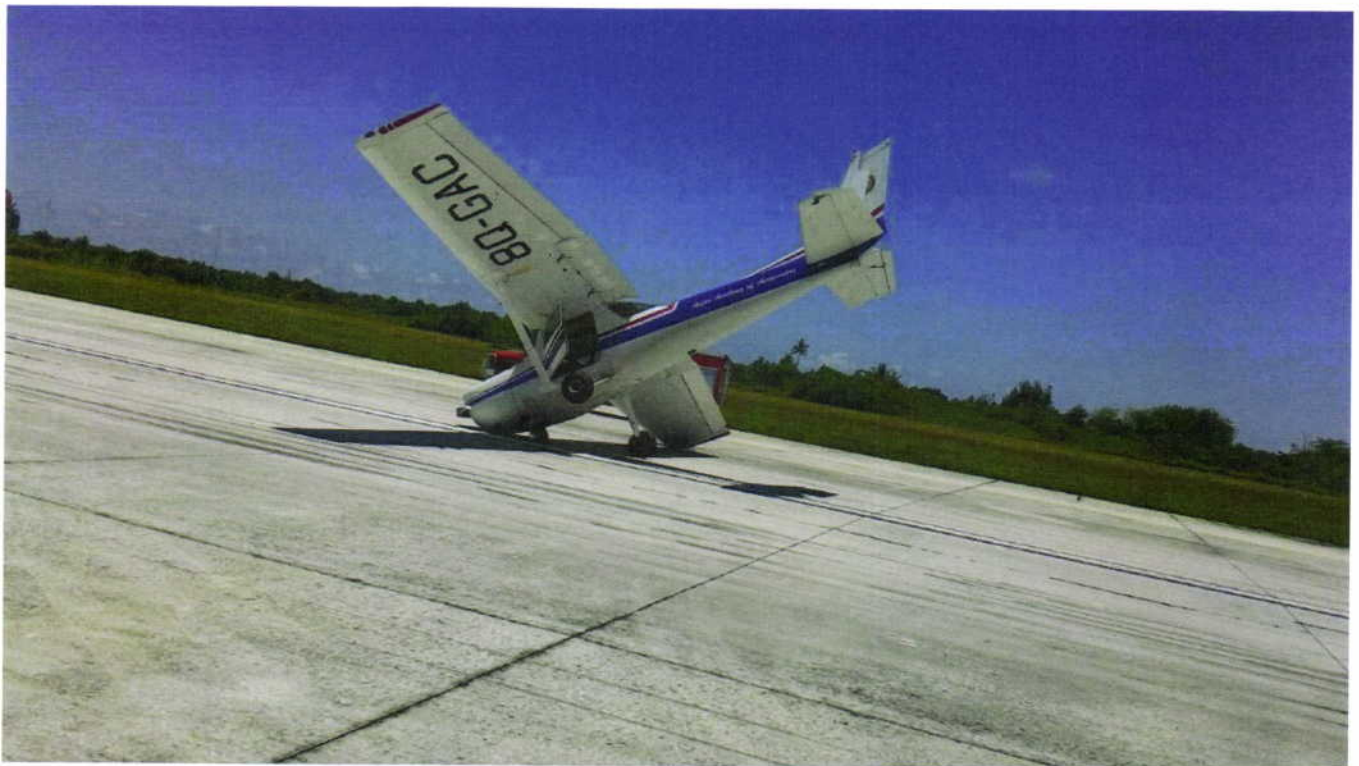
Appendix 2

- The propeller was damaged beyond repair
- Engine mounts deformed damaging shimmy damper, steering rods, nose gear arm assembly and wheel.
- Right wing tip damaged.
- Right hand wing damaged.

On the impact the nose landing gear collapsed (appendix 2) and the propeller stuck the runway. As a result both blades were bent (appendix 3 and 4). The aircraft came to a halt along the runway. (appendix 5)

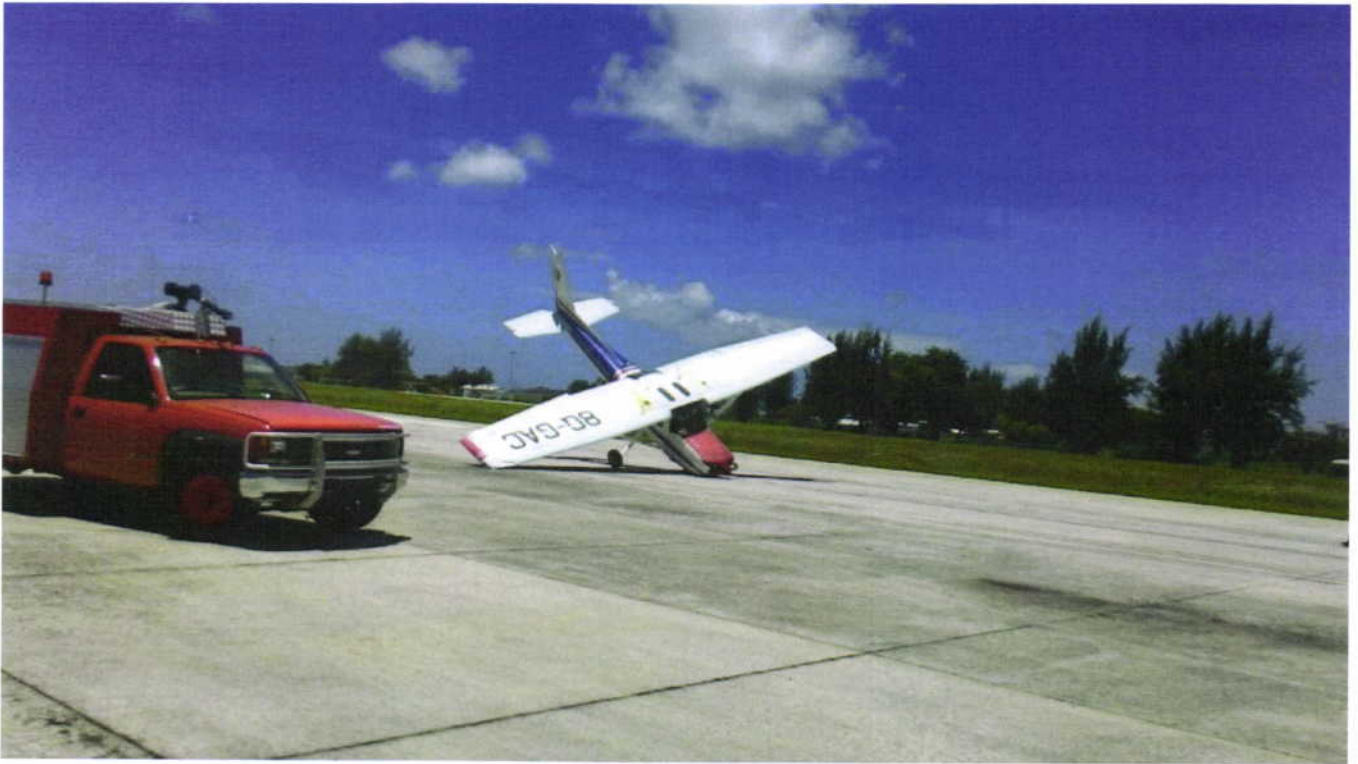
Appendix 5

Aircraft came to a halt on left side of the runway. The student evacuated the aircraft safely.
