ACCIDENT INVESTIGATION AND COORDINATING COMMITTEE
CIVIL AVIATION DEPARTMENT
MINISTRY OF TOURISM AND CIVIL AVIATION

**ACCIDENT REPORT ON
8Q-MAS (TWIN OTTER) COLLISION WITH A SPEED BOAT
Near the Floating Platform at Adaaran Club Bathala, Maldives
On 14th of July 2008**

Operator: Maldivian Air Taxi
Manufacturer: De Havilland (Canadian)
Model: DHC-6-300 (Floatplane)

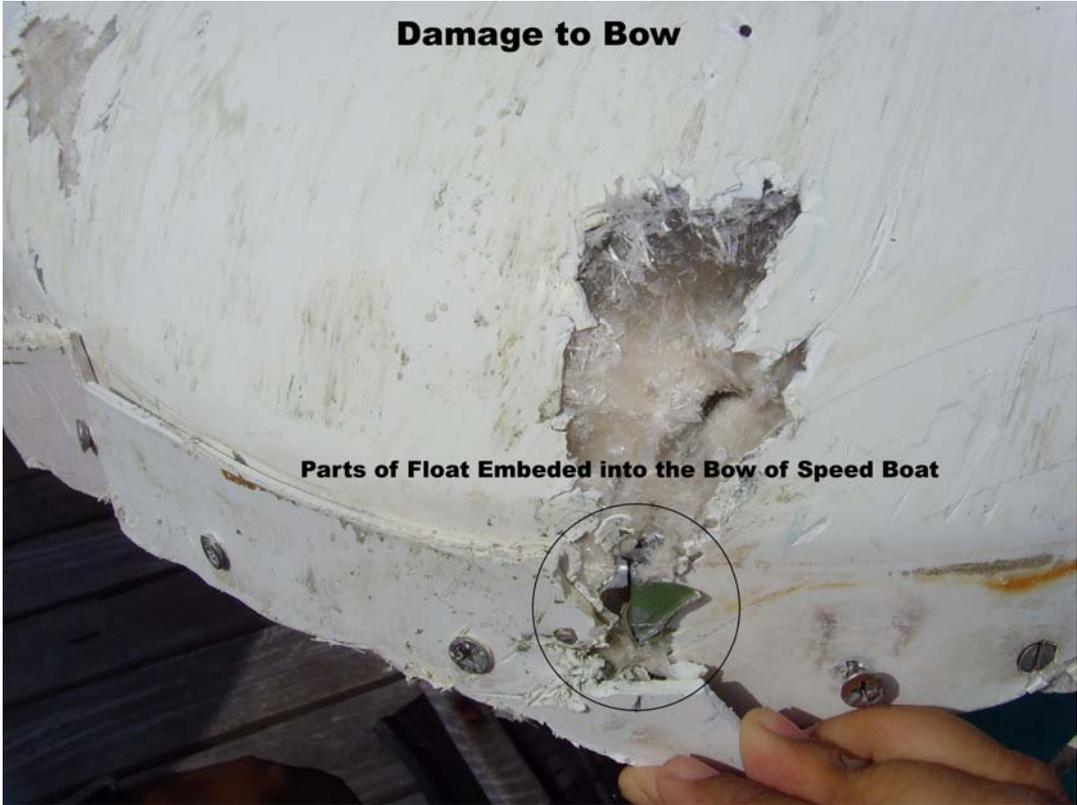
Most of the missing float parts were located between the buoy and the platform. The ruptured keel surface of the RH float was found at 04 04 43.5N, 072 56 38.8E.

The main wreckage of the aircraft was found facing West, tilted towards the left. The LH float was under the belly of the aircraft. The RH engine and RH prop were missing.

- Investigation also revealed that some of the metal parts found underwater near the buoy had pieces of broken glasses inside it and paint of speed boat. This further gives an indication that the right float had impacted with the speed boat.

- The measurements of the impact marks on the speed boat and the RH float suggests that it had both come in contact, taking into account the ruptured area of the RH float.
